HAV-Sentry

A Personalised Hand-Arm Vibration Exposure Meter

The HAV-Sentry system is an innovative, non-intrusive wearable technology that provides personalised measurement of real-time hand-arm vibration exposure with live alerts.

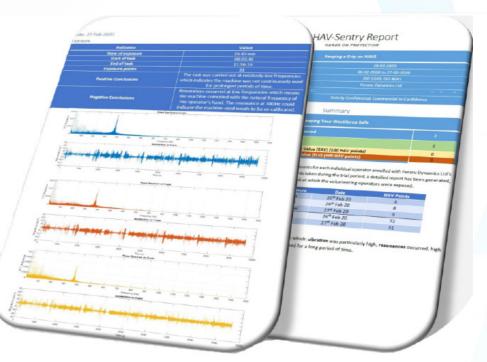
RISK AS	ssessment Report
Date of Report	14 Oct 2021
Period of Data Capture	17 Aug 2021 - 14 Oct 2021
Author	Feraru Dynamics Ltd.
For the Attention of	Feraru Dynamics Ltd.

Generate Risk Assessment Reports instantly

HAV-Sentry Dashboard
